**RIG INSPECTION SURVEY/CONTROL DE**  
**GREEMENT DORMANT**

**S /Y CIEL ROSE**

**27 OF SEPTEMBRE 2022**

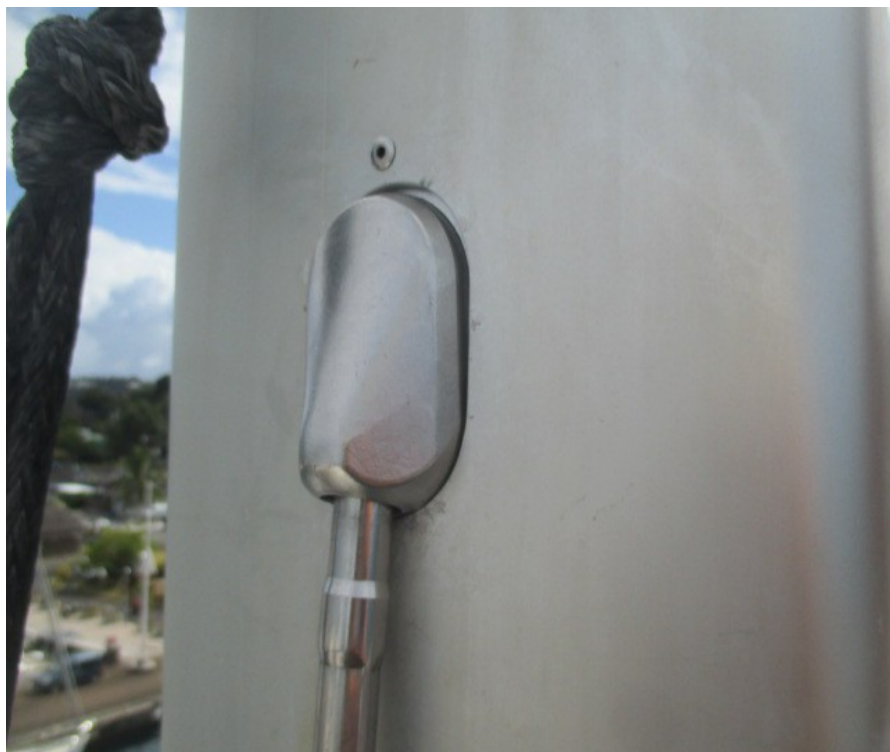
**FOLLOWING RIG INTERVENTION**

**V2D3 TOP FITTING AFTER CHANGED WITH NEW WIRE ON 27/09/2022**

| Emplacement | Ø mm | Ancrage haut / Top fitting | Commentaire / Comment | Ancrage bas / Lower fitting | Commentaire / Comment |
|---|---|---|---|---|---|
| V2-D3 Starbord | 12 | Ball-terminal/shell | <b>NEW WIRE CHANGED WITH NEW SHELL REINFORCED ON 27/09/2022</b> | Eye terminal on Toogle/ discontinu 1 <sup>st</sup> step spreader | Good condition |
| V2-D3 Portside | 12 | Ball-terminal/shell | <b>NEW WIRECHANGED WITH NEW SHELL REINFORCED ON 27/09/2022</b> | Eye terminal on Toogle/ discontinu 1 <sup>st</sup> step spreader | Good condition |

V2D3 are both Changed on 27/09/2022 all sheaves are changed and reinforced After rig inspection all diferents mecanique parts looks in good conditions before sailing

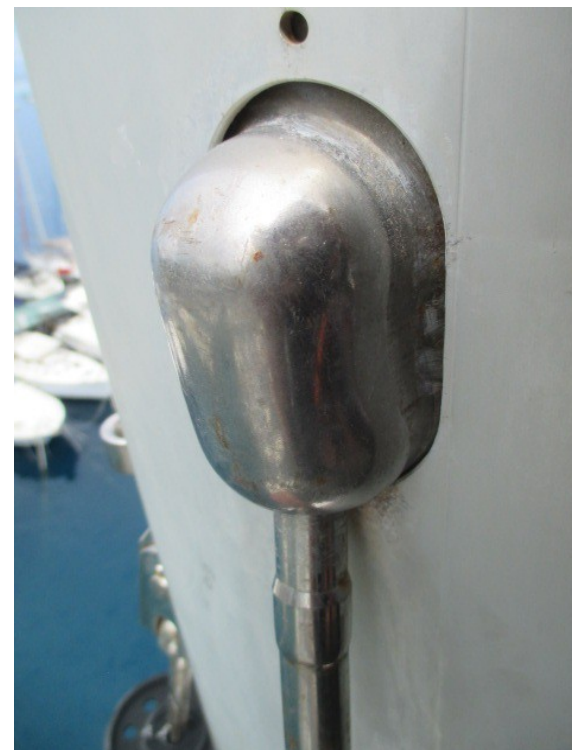
**FOLLOWING RIG INSPECTION ON 12/09/2022**

**V2D3 TOP FITTING DAMAGED SHELL DEFORMATION**
