**RIG INSPECTION SURVEY/CONTROL DE**  
**GREEMENT DORMANT**

**S /Y CIEL ROSE**

**27 OF SEPTEMBRE 2022**

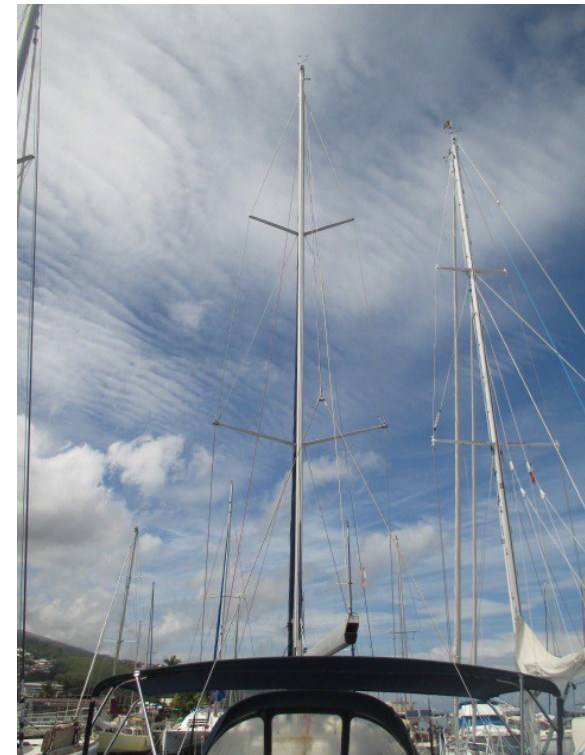
- Type of boat: **SUN ODYSSE 49**
- Years of Build: 2008
- Yard: Jeanneau
- Rigging years old: 14

- Mât / Mast: **SPACRAFT**  
**Mast in furling system Ref:485036**

- Greement / Rigging : **STAINLESS STEEL WIRE 1X19 STRAND**

- Etages de barre de fleche / Number of spreaders : **2**
  - **FIRST STEP DISCONTINU**
  - **SECOND STEP CONTINU**

- Enrouleur Gneoa/ Furler : **FACNOR LS 290**
- Pressions mât /Mast pressures : **15% of wire working load**
